Analysis Report For Magnetic Flowmeter MGG18F

1. Reported Condition of technical problem:
Detector not in service

2. Specification of Detector
Model: MGG18F-300PA11LS5AAJ-X
Production No.: R-9D904-41-013
Production Date: November 2002
Our analysis No.: D-94531

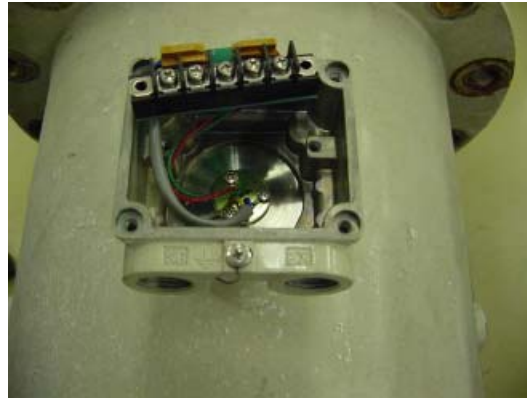
3.1 Visual Inspection:

No problem was found such as moisture penetrization after inspecting inside of wiring terminal

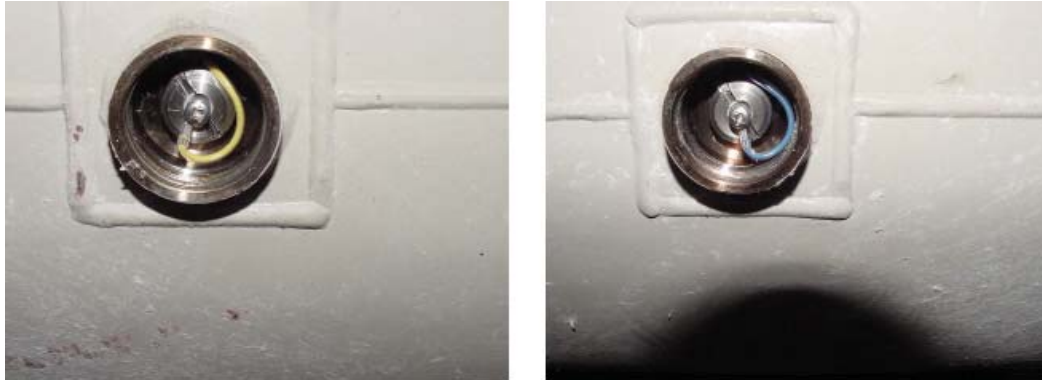
3.5 Observation of electrode:

Observation was made by dismantling a cap of electrode.

No problem such as moisture or dust was recognized on electrode.
